DUTCH
SAFETY BOARD

Crashed after banner pick-up, Piper PA-25-235 Pawnee

The Hague, May 2021

Identification number:	2018045
Classification:	Accident
Date, time of occurrence:	31 May 2018, 10.58 hours ²
Location of occurrence:	Breda International Airport, the Netherlands (EHSE), formerly known as Seppe Airfield
Registration:	SE-KHF
Aircraft type:	Piper PA-25-235 Pawnee D
Aircraft category:	Single engine piston (SEP)
Type of flight:	Commercial banner towing
Phase of operation:	Climb out after picking up of banner
Damage to aircraft:	Destroyed
Flight crew:	One
Passengers:	None
Injuries:	Pilot, fatally injured
Other damage:	None
Light conditions:	Daylight

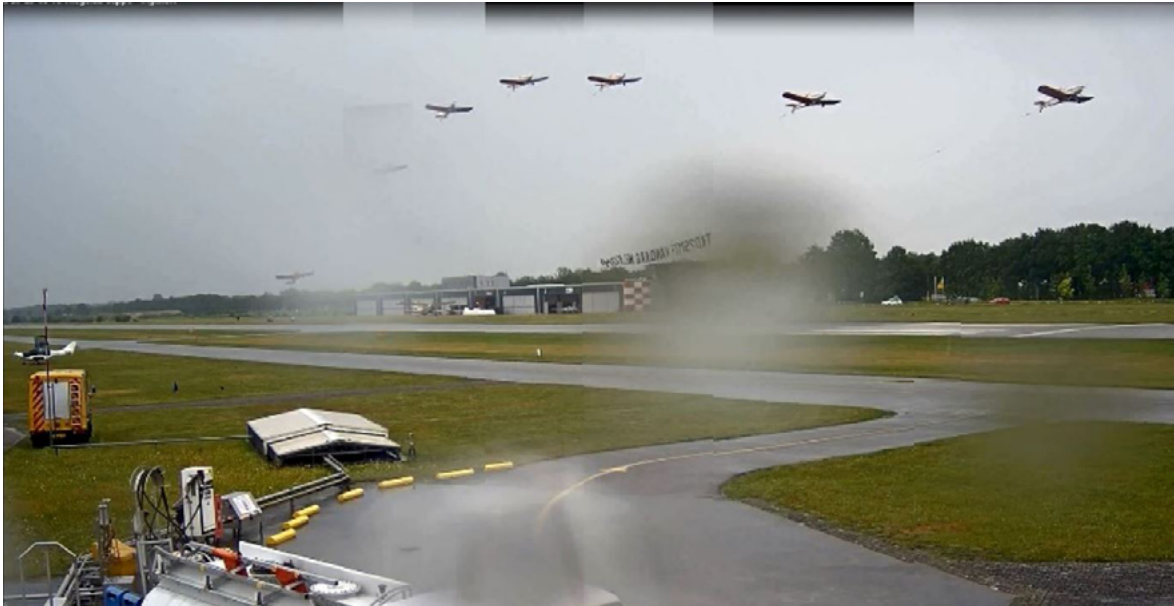
Figure 2: Video compilation of the moment of the banner pick-up and the descending flight path. (Source: Breda International Airport, modified by the Dutch Safety Board)

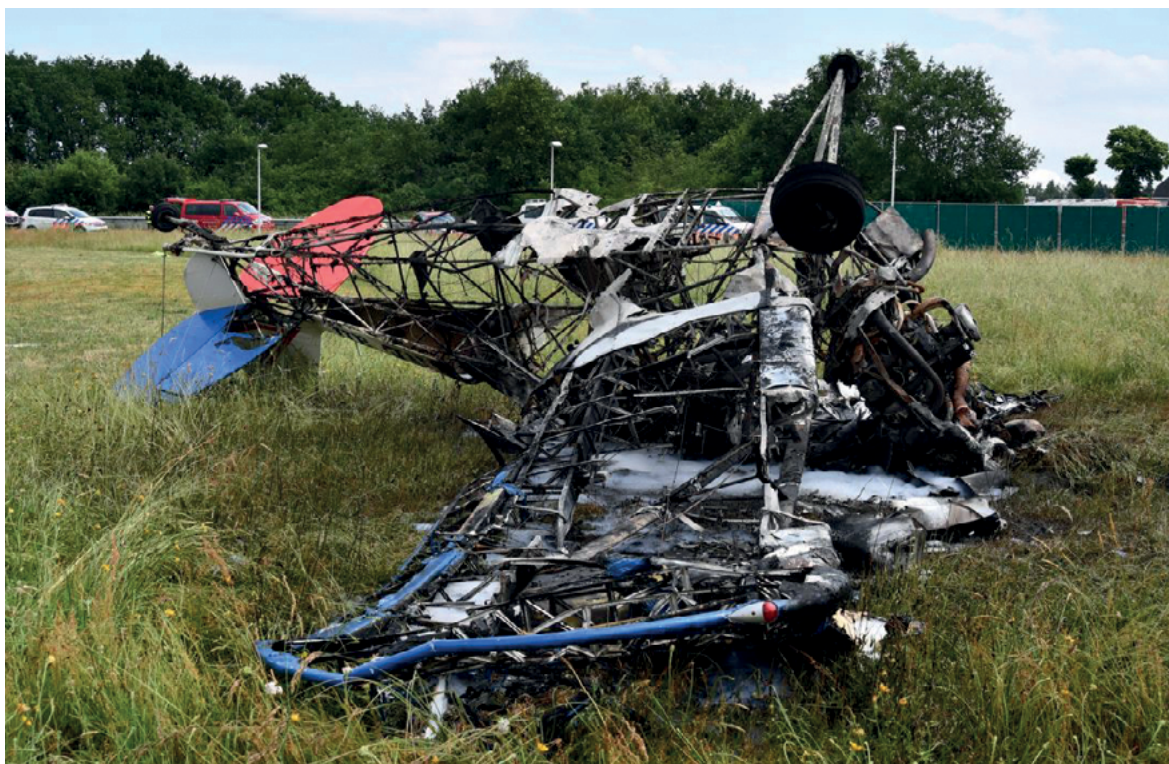
Figure 4: Wreckage of SE-KHF. (Source: Dutch Aviation Police)

The aeroplane was destroyed by the impact of the crash and subsequent fire. Although most of the aeroplane was severely damaged, a technical investigation was performed on the engine, cockpit controls, banner tow release system and the propeller. The following findings were made:

- a. The technical state of the engine did not reveal any malfunctions.
- b. The cockpit engine controls were found to be in the following positions: throttle – *full power*, mixture – *rich* and carburettor heating – *cold*.
- c. The aeroplane was equipped with a towing and tow-release installation. The banner release installation was tested and functioned normally.
- d. The wooden propeller blades of the 4-blade propeller were completely fragmented on impact with the ground, only the propeller hub/core was still attached. The fragmentation of the propeller blades showed that the engine was running at high rpm.

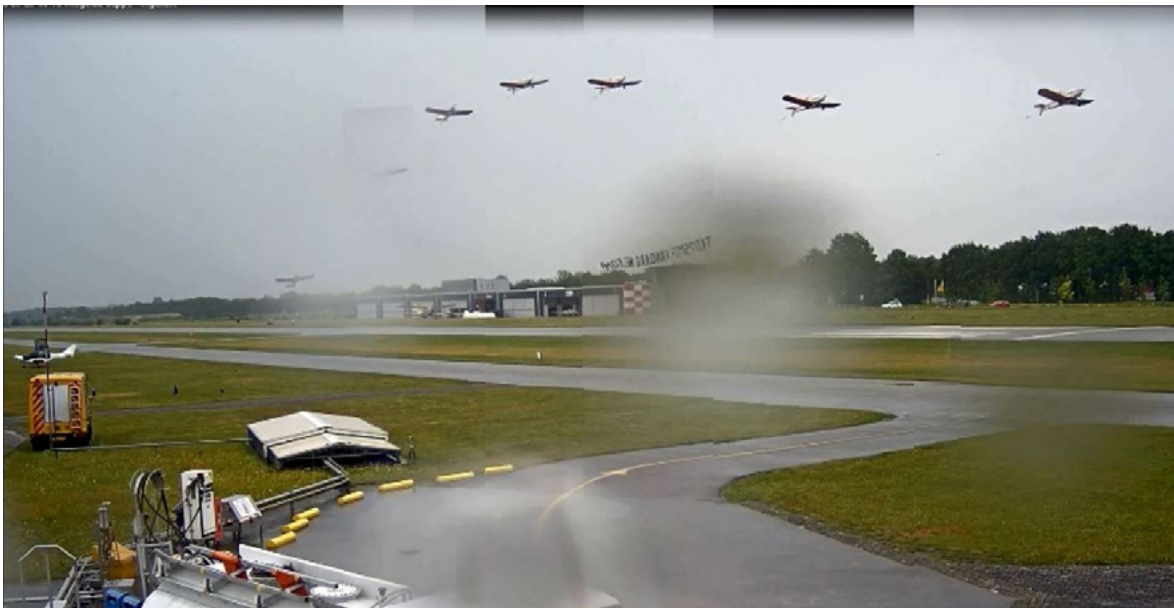
The flight path reconstruction in Figure 8 shows that after the pick-up of the banner, the aeroplane quickly developed a nose high attitude and a descending flight path. These indications are characteristic for a low airspeed situation. Therefore, an estimation of the aeroplane's hypothesized low airspeed was made by using the video images.

Figure 8: Video compilation showing the moment of the banner pick-up and the descending flight path.
(Source: Breda International Airport, modified by the Dutch Safety Board)

The aeroplane flew 620 metres from the position where it picked up the banner until the position where it fell over its right wing in 30 seconds. From this distance and time, a ground speed of 47 mph IAS (41 KIAS) (21 m/sec) was calculated. Taking into account that a head wind component of approximately 6 mph (5 knots) was present (the windssock is hanging almost vertically down), the aeroplane flew with an estimated average airspeed of 53 mph IAS (46 KIAS).

The recommended minimum airspeed from the aircraft flight manual for normal operations is 61 mph IAS (53 KIAS). For banner towing operations, the recommended

minimum indicated airspeed for the similar type aeroplane is 67 mph²⁰ IAS (58 KIAS). By comparing these airspeeds with the above calculated average airspeed, it is inferred that the airspeed had decreased to below the minimum recommended flying airspeed for normal and for banner towing operations, and that as a result the aeroplane had stalled.
