DUTCH
SAFETY BOARD

Fatal loss of control accident with a Pipistrel Alpha Electro near Stadskanaal airfield

The Hague, July 2020

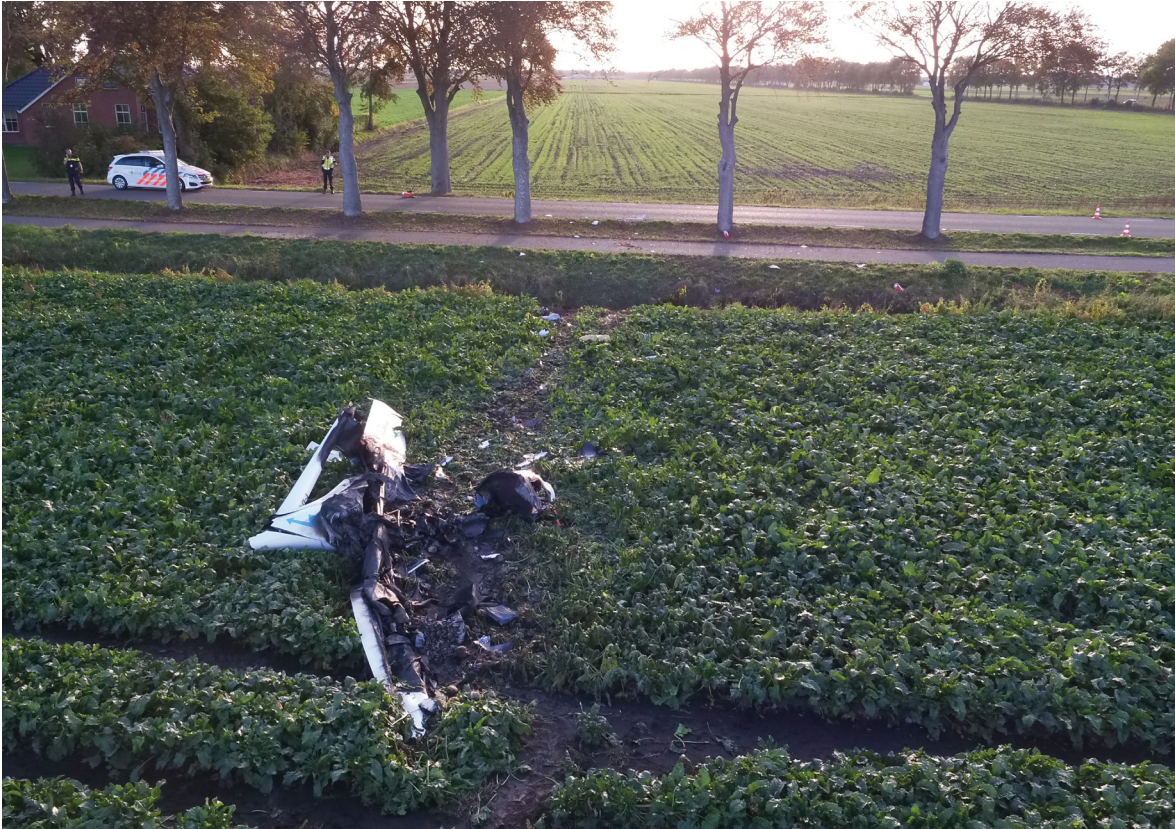
After turning from downwind to base leg, the aeroplane developed a left overbanked and nose down attitude, resulting in a high sink rate. After having turned for approximately 270 degrees, the aeroplane came down on a country road, before bouncing between two trees and over a cycling path and a ditch.² The aeroplane then hit the embankment of the ditch from where it skidded on farmland and came to a halt about 30 meters from the initial impact, see Figure 2. Shortly hereafter the aeroplane caught fire. Bystanders managed to carry the pilot out of the aeroplane.

Figure 2: Accident location. (Source: Dutch Aviation Police)

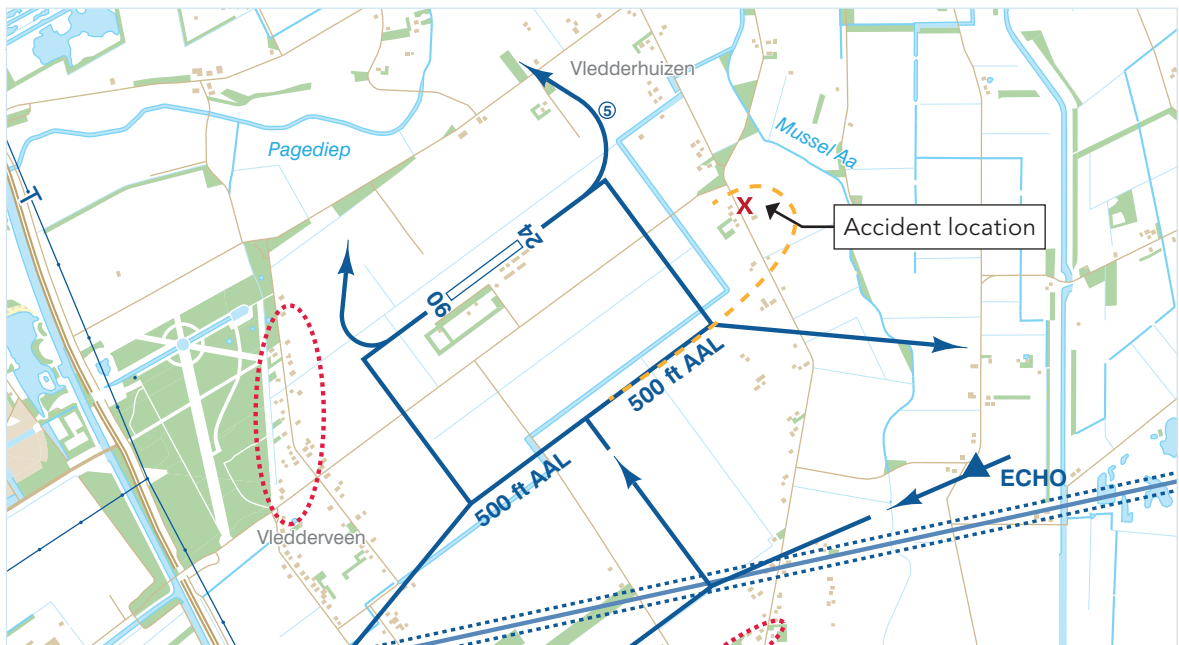
As depicted in Figure 3, the location of the crash was outside the circuit area.

Figure 3: Accident location. (Source: EHST Visual Approach Chart, AIP the Netherlands)

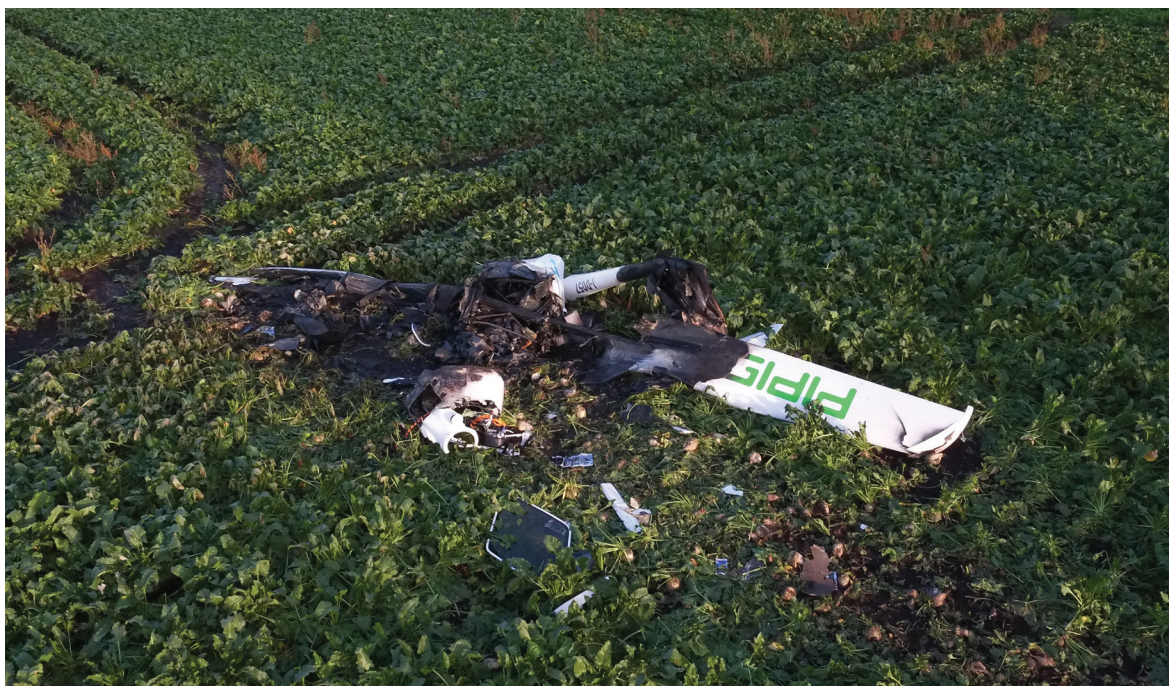
The aeroplane was destroyed as a result of the crash and the post-impact fire, see Figure 4.

Figure 4: Wreckage of the aeroplane. (Source: Dutch Aviation Police)

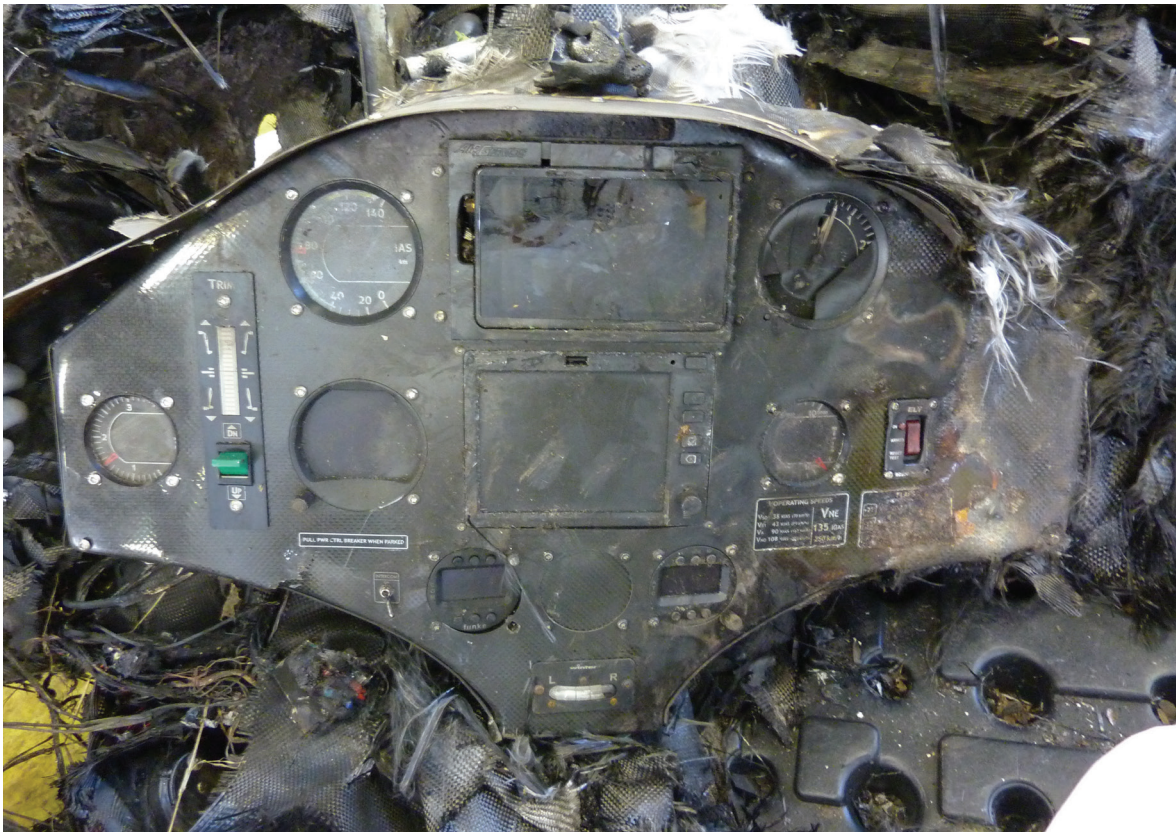
Figure 8: Instrument panel and flight instruments.

The aeroplane came to a standstill in the farmland at a distance of approximately 30 meters after the initial impact with the road. This was caused by the aeroplane having a considerable forward airspeed (80 knots IAS indication on airspeed indicator) in relation to the vertical speed (more than 2,000 feet per minute descent) at the moment of impact.

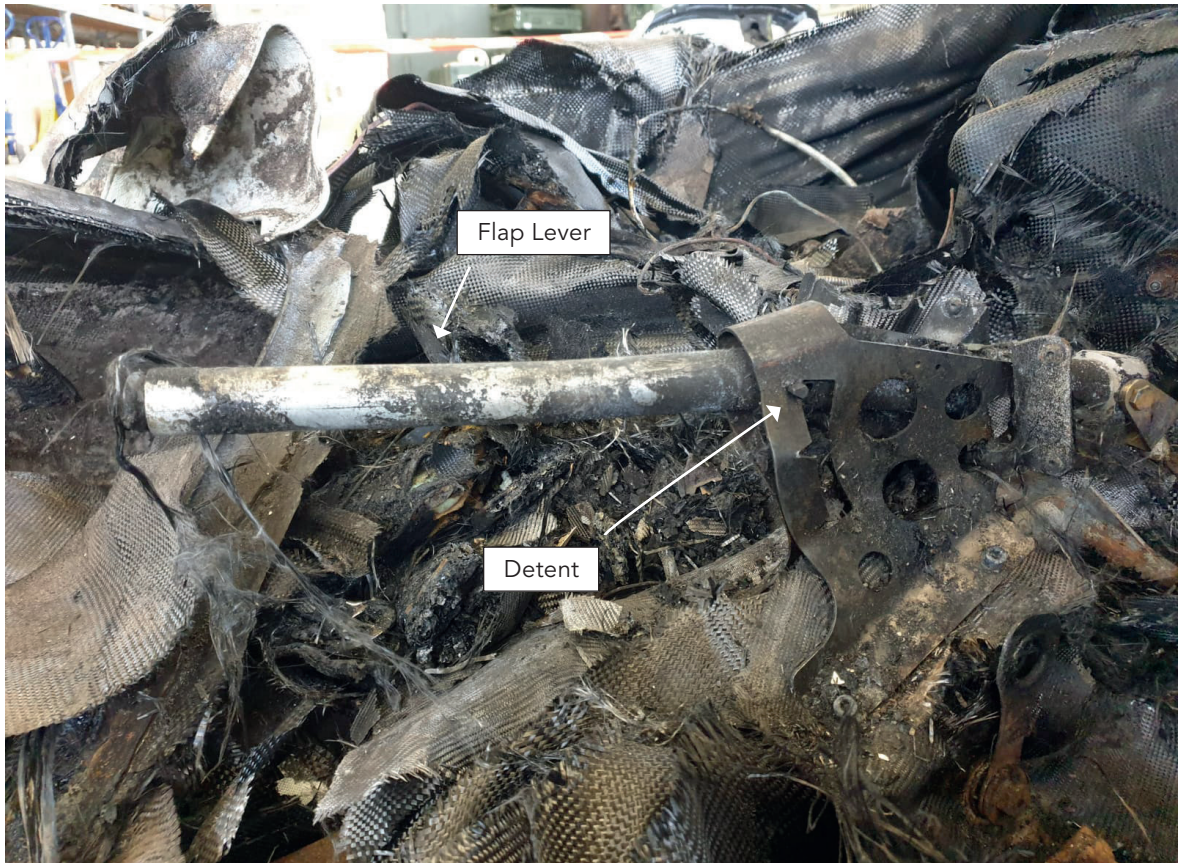
The aeroplane was found with the flap lever in the +25° ('full flap') position, see Figure 12. This is the configuration for landing. The Pilot's Operating Handbook mentions that the flaps should be selected to +25° on final. With the flaps fully extended (resulting in increased drag forces), the aeroplane is more susceptible to adverse yaw and may therefore require extra attention to rudder coordination. The adverse yaw, which is amplified by the full wing span flaperons of the aeroplane, increased the chance of the loss of control.

Based on the lever construction, it is unlikely that the lever position was changed by the forces of the impact. The actual position of the flaps at the moment of the impact could not be determined, because of the damaged flaperons and wings as a result of the impact and post impact fire. Because of the flap lever construction, it is assumed that the flaps were put deliberately in the full flaps position. It could not be determined why full flaps were selected before being on final.

Figure 12: Flap lever set in detent for full flaps.

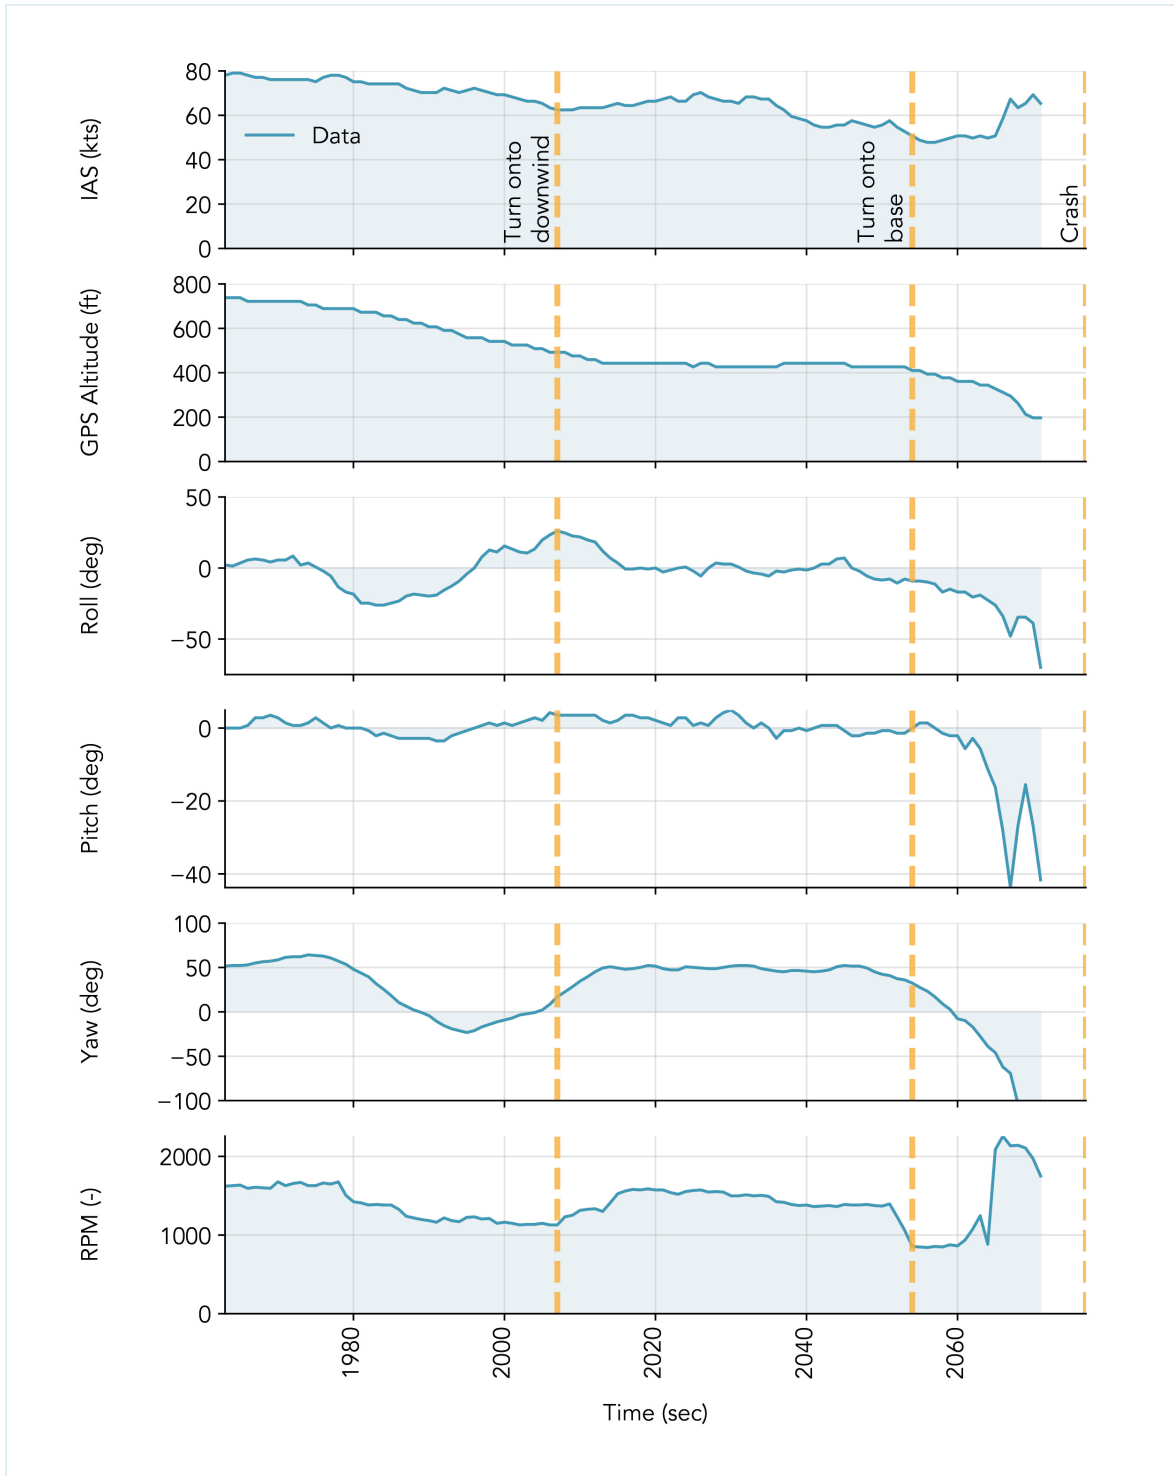
These battery problems might suggest a relation with the cause of the accident. The technical investigation of the power supply however did not reveal any abnormalities. Furthermore, flight data indicates that moments before the accident the aeroplane maintained altitude with RPM being about 1,550, decreasing to approximately 1,370 during the last part of the downwind leg. According to the manufacturer, power needed for level flight and on downwind is 20 kW, which equals approximately 1,500-1,600 RPM (depending on elevation).²⁹ The fact that both altitude and RPM remained more or less constant on downwind, suggests that the motor and the batteries functioned normally. See Appendix B.

Figure 13: Flight parameters, derived from the altimeter's air data computer.
