Environmental impacts associated with the planned expansion of Karel's Beach Bar, Bonaire

October 2011

By Dr Mark Vermeij

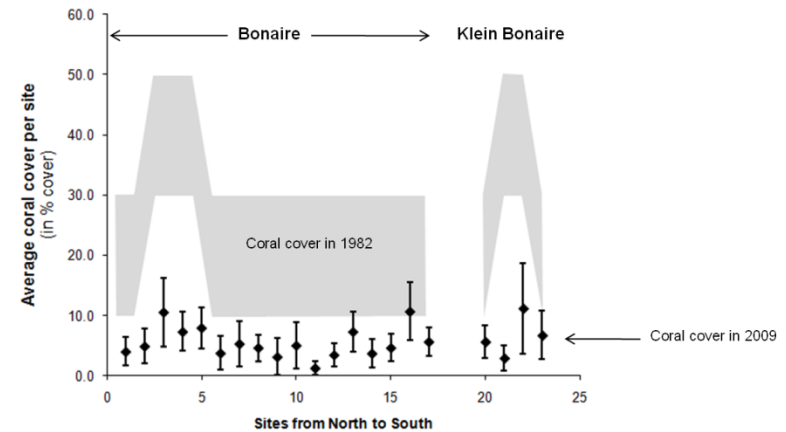
Figure 1. Change in coral cover from 1982 (estimated range calculated from Van Duyl 1985) to 2009 (values are average cover as calculated by an IUCN expedition to Bonaire in 2009; error bars are 95% confidence intervals). In total 17 sites were monitored from North to South on Bonaire (sites 1 to 17) and 4 on Klein Bonaire (20 to 23). All measurements were taken between 8 and 10m.

Bonaire is no exception to this worldwide pattern of reef deterioration (**Figure 1**) and coral cover has decreased in shallow water (<20m) from ~44% to ~18% between 1973 and 2003. These trends have been confirmed by other studies (e.g. Steneck and Arnold 2009, Bal et al. 2005, Grimsditch et al. 2011) clearly
