DUTCH
SAFETY BOARD

Fatal loss of control accident with a Pipistrel Alpha Electro near Stadskanaal airfield

The Hague, July 2020

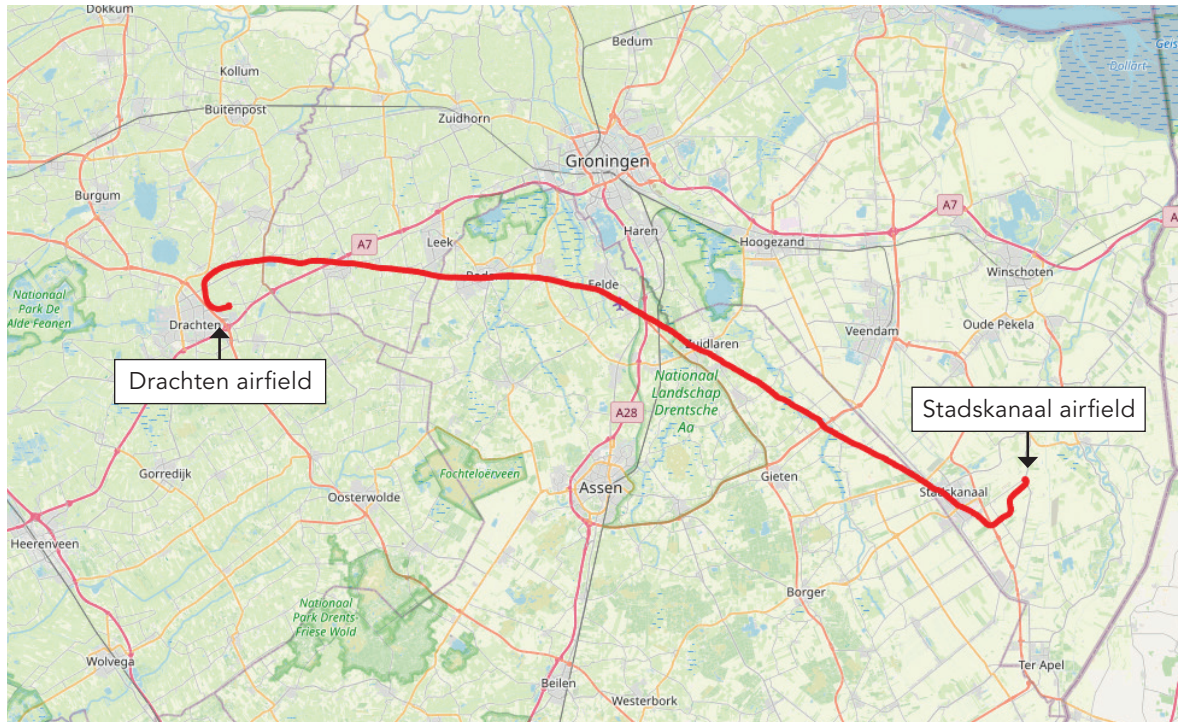
Figure 1: Flight route of I-D057 (red line). (Source: ATC the Netherlands and OpenStreetMap)

The pilot departed Drachten airfield's runway 26 at 12.12 hours. He made a right turn and set course towards Groningen Airport Eelde. En route, the pilot flew at altitudes between 500 and 1,000 feet AMSL. He contacted Eelde Tower requesting to enter the control zone. After crossing the Eelde control zone the aeroplane flew towards Stadskanaal airfield, see Figure 1.

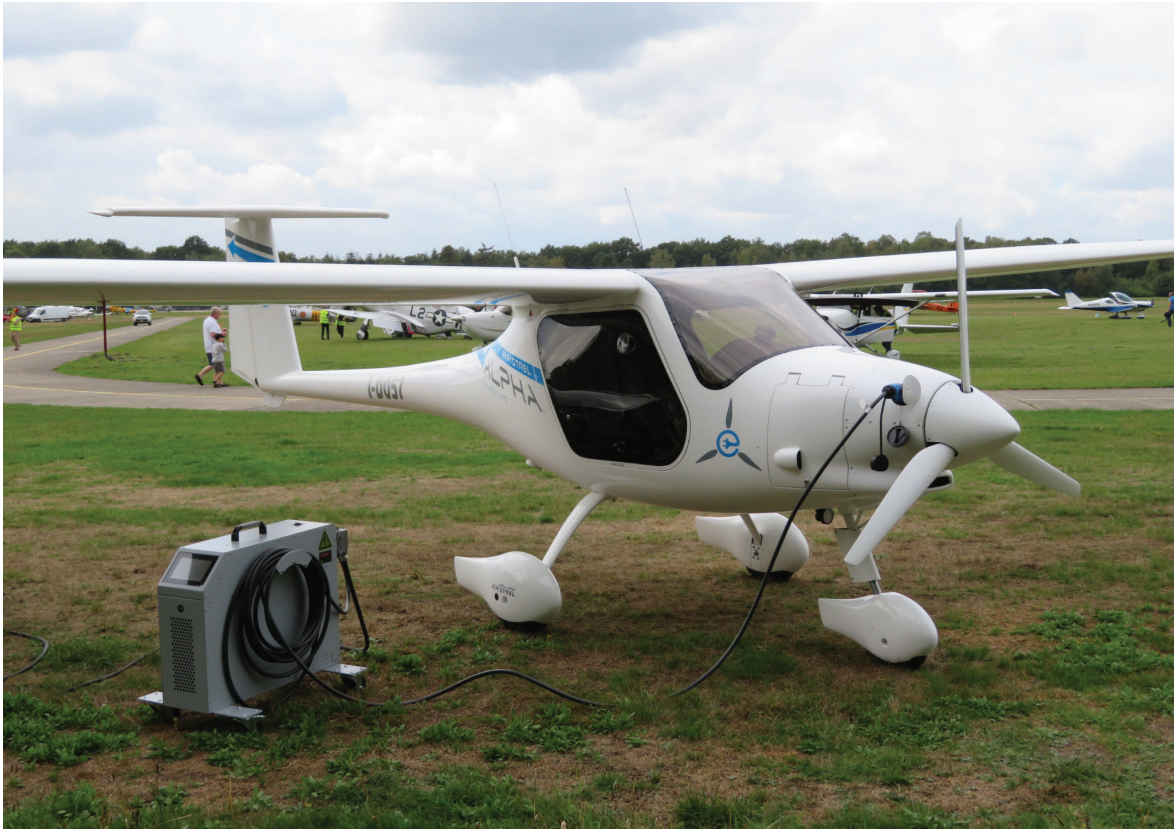
Figure 5: Archive photo I-D057. (Source: H. Ranter)

The Pipistrel ALPHA Electro 167 is a 2-seat electric-powered T-tail high-wing aeroplane, made almost entirely of composite materials, see Figure 5. All composite parts are made of glass, carbon and kevlar fiber. It has a 10,5 meter wingspan and a non-retractable undercarriage. The aeroplane features flaperons, meaning that one movable surface on the trailing edge of each wing acts both as the flap and the aileron. Three flap settings can be selected: retracted (0°), +15° and +25°. The elevator trim is electric.

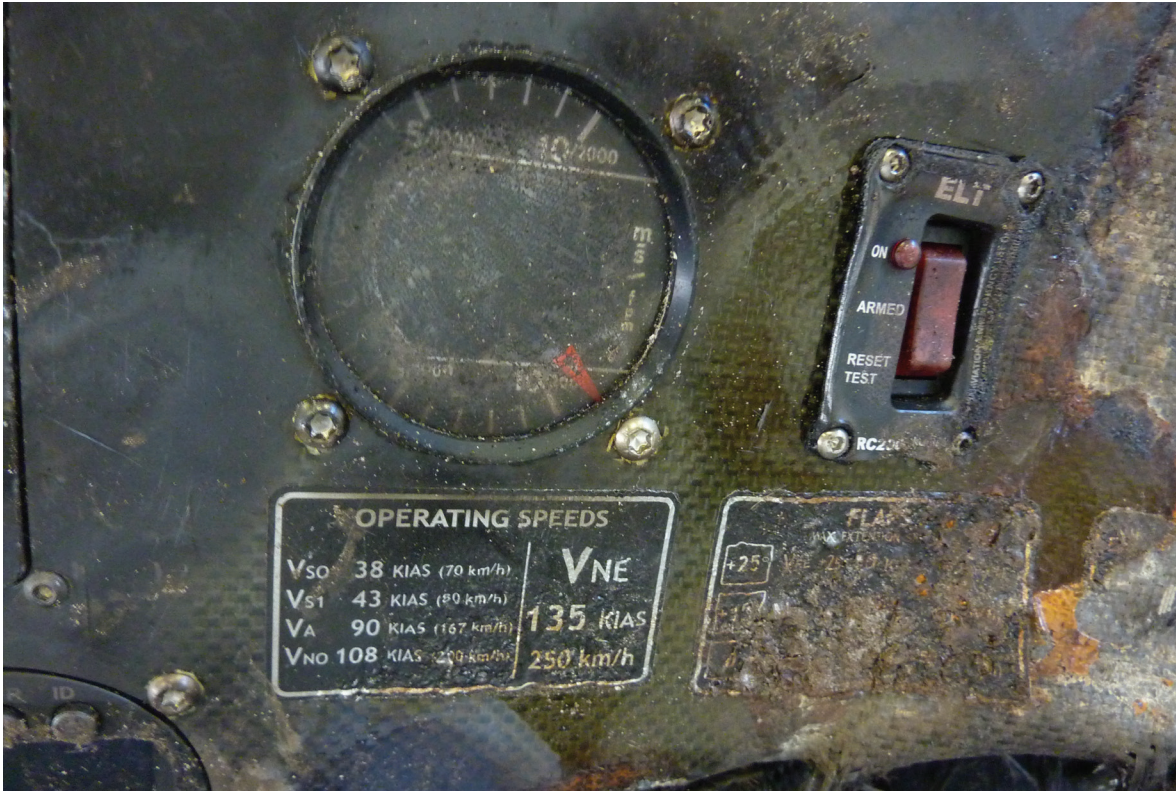
Figure 6: Placard in cockpit with operating speeds.

The operating speeds of I-D057 were shown on a placard in the cockpit. See Figure 6.

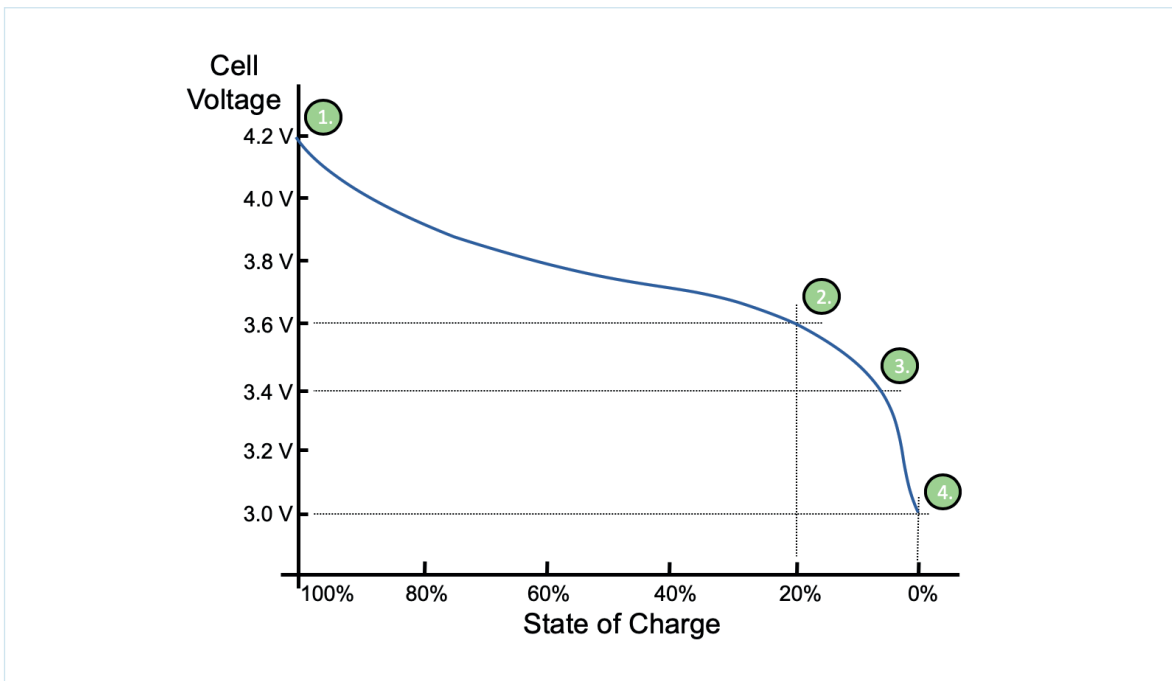
Figure 7: Typical lithium-ion battery discharge curve.

The typical discharge curve of the lithium-ion battery cell is shown in Figure 7. A lithium-ion cell has a nominal voltage of 3.7 V, which is the default, resting voltage of a battery pack. Lithium-ion batteries are fully charged when they reach 4.2 V/cell (point 1); their minimum safe charge is 3.0 V/cell (point 4). The discharge of a cell is not linear, but it is relatively flat and then drops rapidly. This accelerated discharge occurs at about 3.6 V/cell (point 2) and becomes very rapid at 3.4 V/cell (point 3).
